Conducting disaster damage assessments with Spatial Video, experts, and citizens

Evan Lue^{a,*}, John P. Wilson^a, Andrew Curtis^b

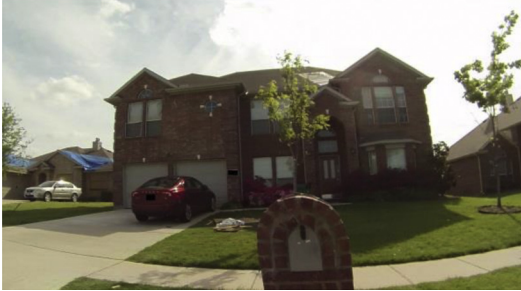
Some shingles and/or siding missing Debris against or around dwelling Structure damage considered to be nuisance Dwelling is livable without repairs
Minor

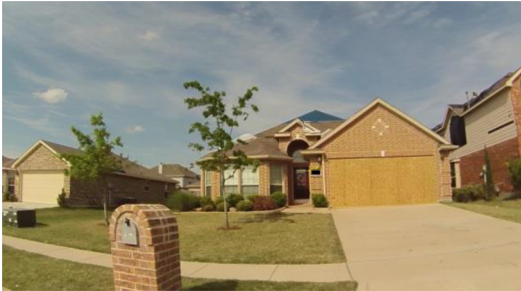
Minor structural damage Damage to small sections of roof Numerous broken windows Large portions of roofing material and/or siding missing Penetration damage where it is believed no structural damage has occurred
Major

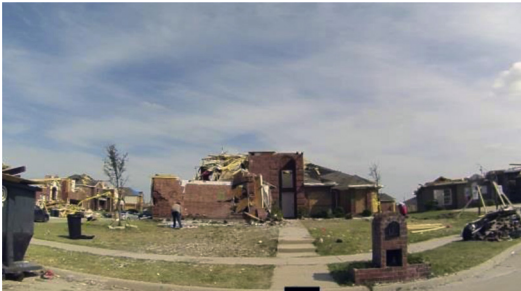
Large portions of roof missing or debris penetration One or two walls missing
Destroyed

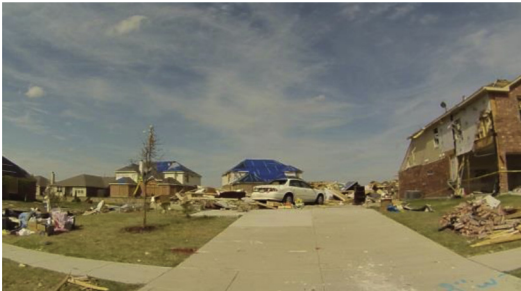
Total collapse Shifted on foundation Not economically feasible to repair

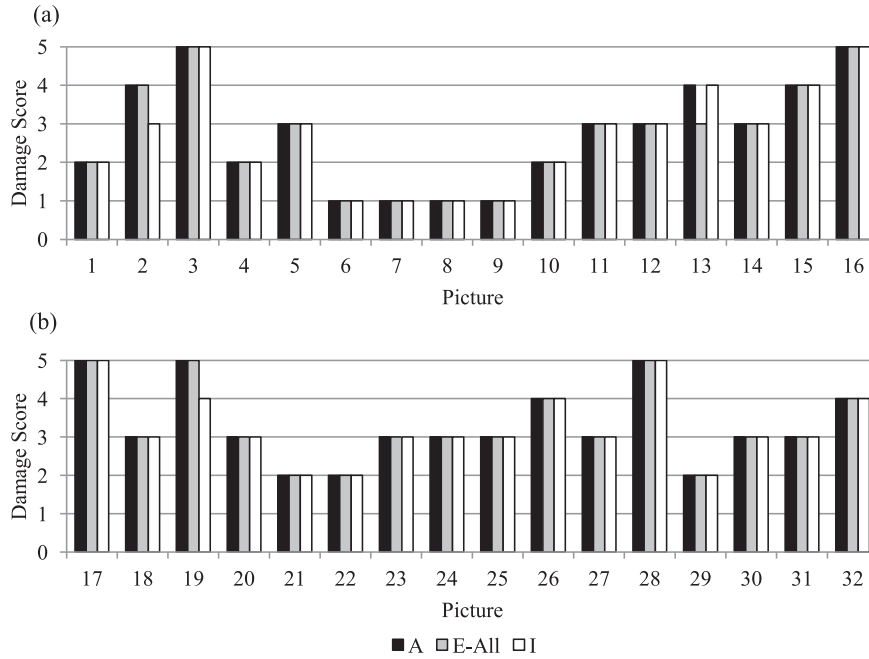
Fig. 2. Mode of damage scores for the ordered (a) and random picture sets (b) as scored by Groups A, E-All, and I.

Agreement in damage scores was similar between the inexperienced and experienced groups. The mode of damage scores for each picture is shown in Fig. 2 in three series: as scored by all respondents, by the experienced respondents only, and by the inexperienced respondents only. The mode of the experienced response disagreed with the mode of the inexperienced response in three cases.

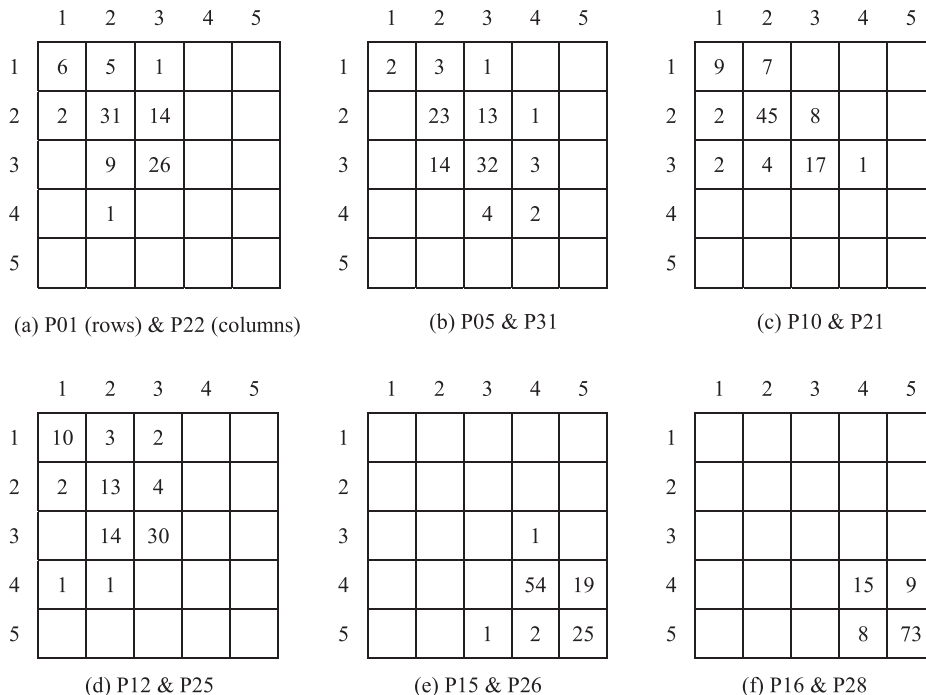
Fig. 3. Contingency tables for each pair of repeated pictures as rated by Group A.

Contingency tables were calculated for each repeated picture, with the score assigned the first time recorded as rows and the second score recorded as columns (Fig. 3). In each contingency table, the diagonal series of boxes from (1, 1) to (5, 5) represent repeat damage scores. Boxes above the diagonal represent pictures that were assessed the second time as being more damaged. Boxes below the diagonal represent pictures that were assessed the second time as being less damaged. The repeat ratings ranged from 60% (P05 and P31) to 84% (P16 and P28) and the unequal sums between tables are due to missing data.
