16. Watershed Assets Assessment Report

Preferred Citation: Sheng, J. and Wilson, J.P. 2008. *The Green Visions Plan for 21st Century Southern California. 16. Watershed Assets Assessment Report*. University of Southern California GIS Research Laboratory and Center for Sustainable Cities, Los Angeles, California.

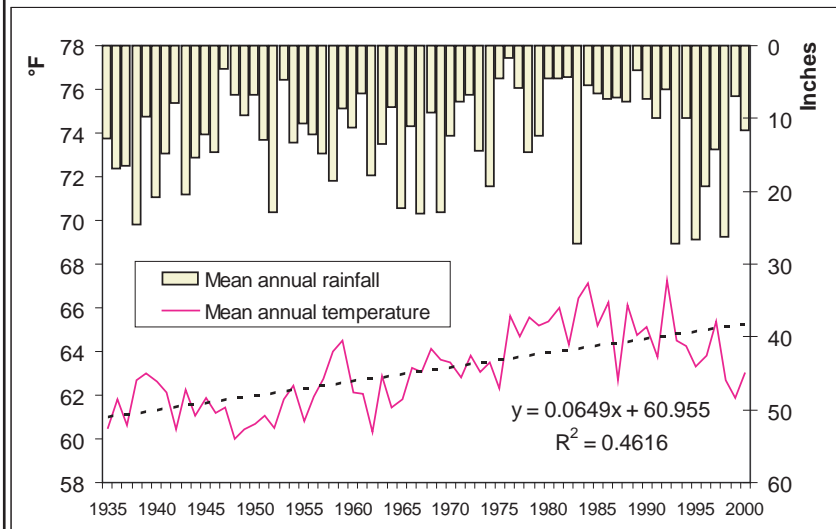
Figure 2.4 Annual rainfall and temperature in Culver City station from 1935 to 2000

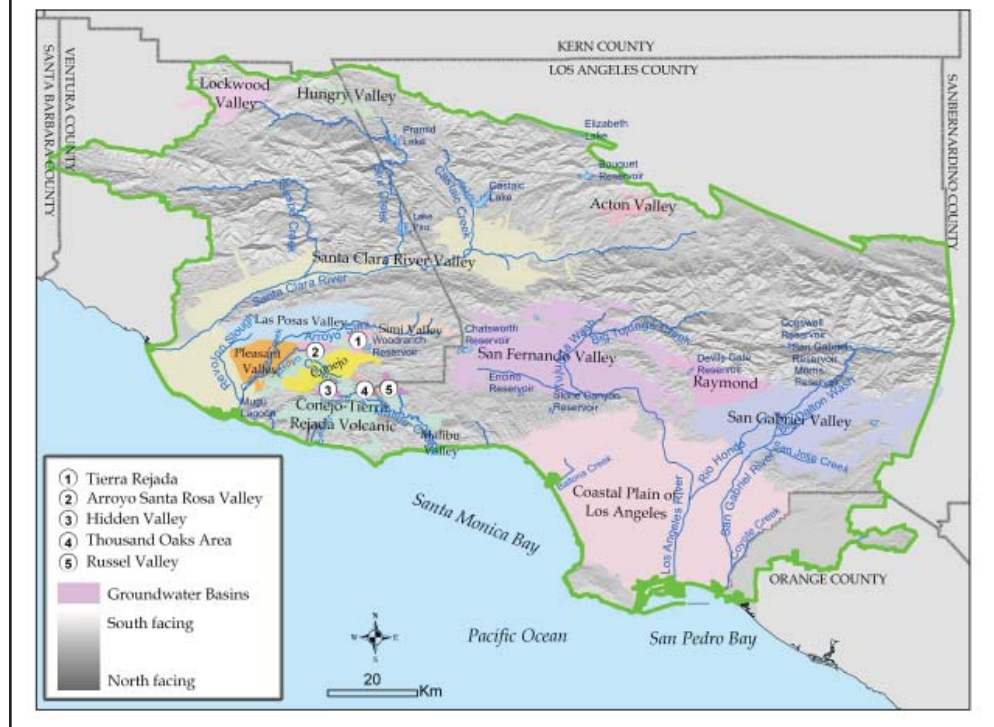
Figure 2.6 The five 8-digit HUC watersheds and distribution of major groundwater basins in the GVP study area

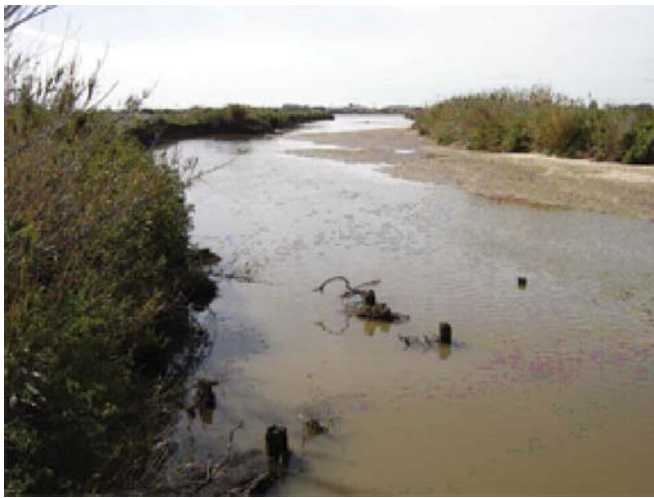
Photo 3.1 Mugu Lagoon

The fifth order streams consist of Arroyo Simi, Arroyo Las Posas, and Calleguas Creek originating from the extreme limits of Simi Valley in the east and northeast, then westerly through the urban landscape such as Simi Valley, Las Posas Valley (as Arroyo Las Posas) to Oxnard Plain (as Calleguas Creek) and the Pacific Ocean at Mugu Lagoon (Photo 3.1). Various reaches along

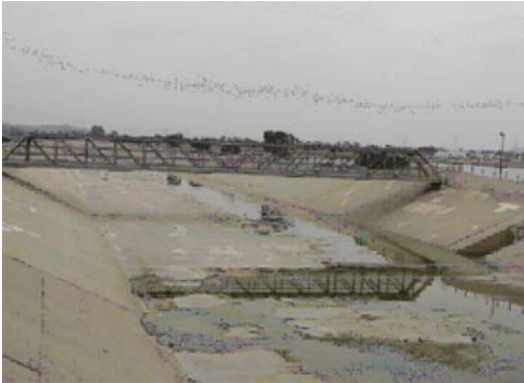
Photo 4.1 Tujunga Wash Channel

flat valley areas with a mean channel elevation of 852.8 ft and flows to Tujunga Wash Channel in a reinforced concrete box-type channel (Photo 4.1), which was built in 1952, extending approximately 9.5 mi from Hansen Dam to the confluence with the Los Angeles River. Below the confluence with Tujunga Wash, the Los Angeles River (6th order) is a section of the river that remains in a semi-natural condition, also known as the hybrid river. The area supports a variety of low-density uses and is periodically inundated, which allows the growth of willows, reeds and other vegetation, and attracts wildlife. The reach of Glendale Narrows has a rocky, unlined bottom with concrete-lined sides (Photo 4.2). South of Glendale Narrows, the river is contained in a concrete-lined channel down to Long Beach (Photo 4.3).

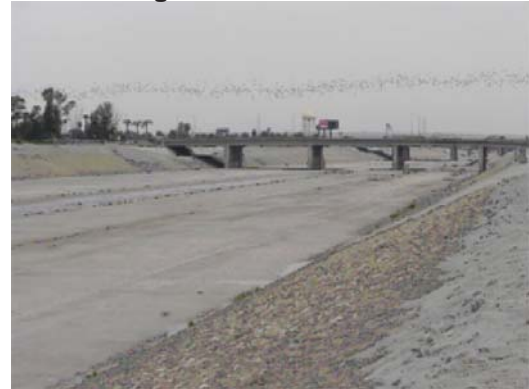
Photo 4.3 Concrete-lined channel along the Los Angeles River

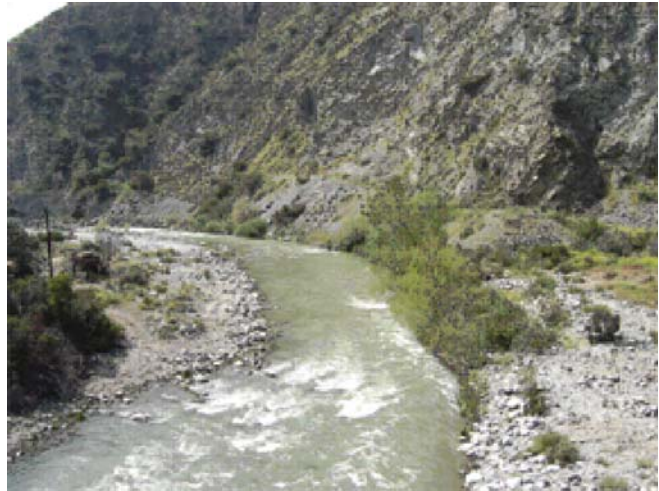
Photo 5.1 San Gabriel River passing through San Gabriel Canyon

The 2nd and 1st order streams are mainly located in headwaters originating in the San Gabriel Mountains, San Jose Hills, and Puente–Chino hills. These streams pass through steep vegetated canyons and carry large amounts of eroded debris off the mountains (Photo 5.1).

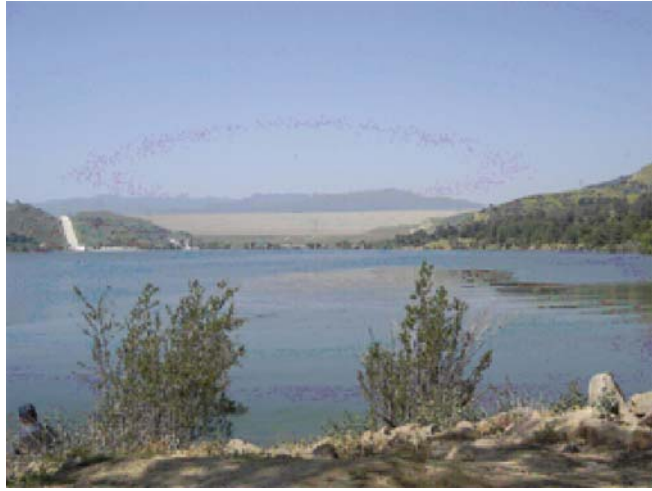
Photo 6.4 Castaic Reservoir, Ventura County

Forebay is part of the Castaic Reservoir System. It is an enclosed section of the northwest arm of Castaic Lake.

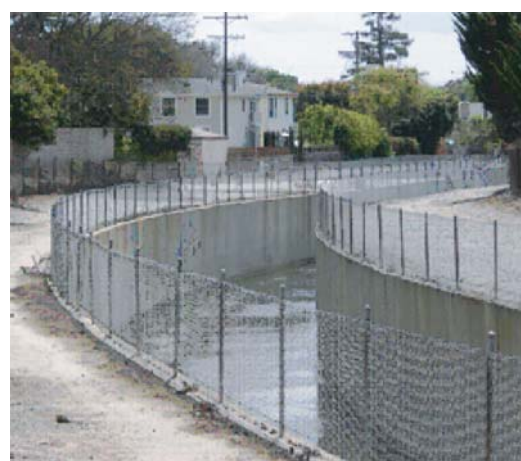
Photo 7.5 Sepulveda Channel that drains to Ballona Creek taken in 2006

endpoint for runoff from a highly industrialized area. These urban drains generally originate at curb inlets on city streets and increase in size as they progress in the downstream direction to an open channel or detention basin. In some locations the drainage system is no longer adequate, and localized flooding occurs during storms.
